Manhole Inspection Summary

Manhole # S35KK1022MH

Insp Date: **3/10/07 10:53 AM**

Location Address: **204 STRATFORD RD**

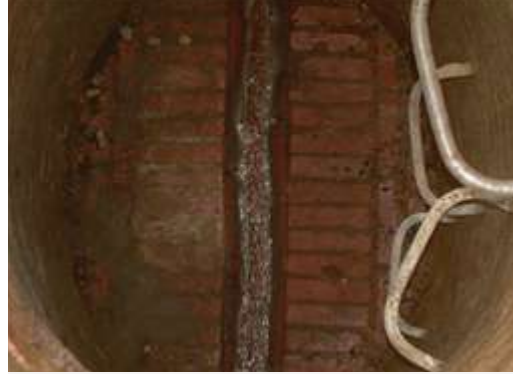
Top View

Evidence of surcharge - Bench debris.

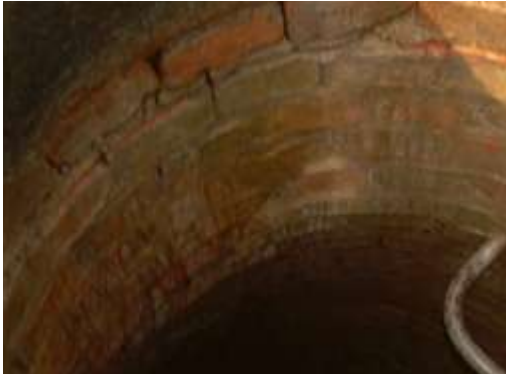
Defect

Frame Offset: **0** (in.) Condition: ☐ Sound ☐ Cracked ☒ **Leaks**

Condition: ☐ Sound ☐ Cracked ☐ Root Intrusion ☐ Loose Brick ☒ **Deteriorated**

Infiltration: ☐ None ☒ **Joint** ☐ Cracks ☐ Mortar ☐ Roots ☒ **Wall**

Frame leaks. Adjustment deterioration and infiltration. Corbel and Barrel infiltration.

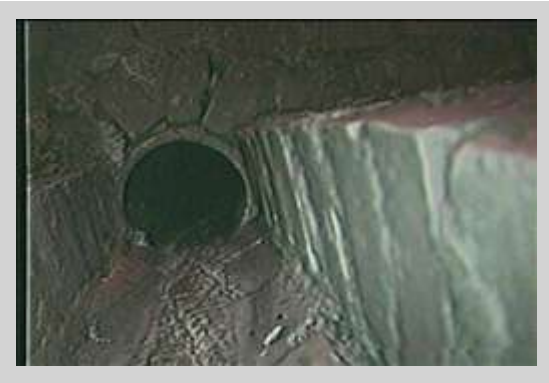
6 in. Circular Gravity Sewer Pipe Out @ 12 O'Clock

Barrel deterioration and infiltration. Channel deterioration

Infiltration: **Evidence** Pipe Seal Cond: **Cracked**

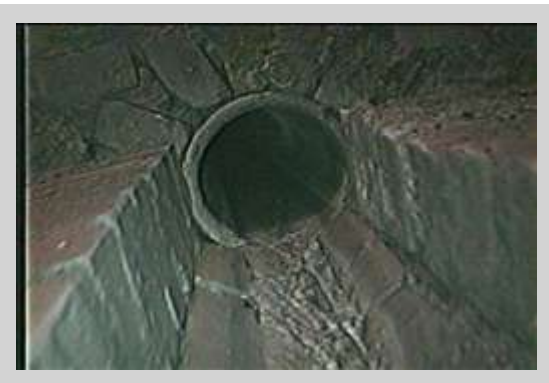
6 in. Circular Gravity Sewer Pipe In @ 6 O'Clock

Barrel deterioration and infiltration. Channel deterioration.

Infiltration: **None** Pipe Seal Cond: **Cracked**
